REPORT NO. DPS/TS1-200/19

RELATIVE EFFECTIVENESS OF TNT,
COMPOSITION B, AND H6 AS MINE FILLERS (U)

Nineteenth Report on Ordnance Project No. TS1-200

OCTOBER 1959

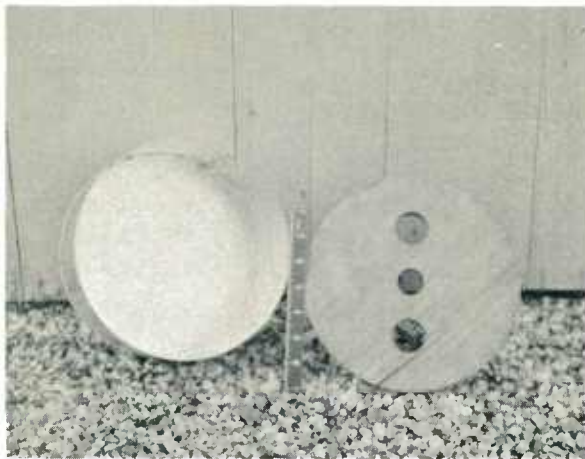
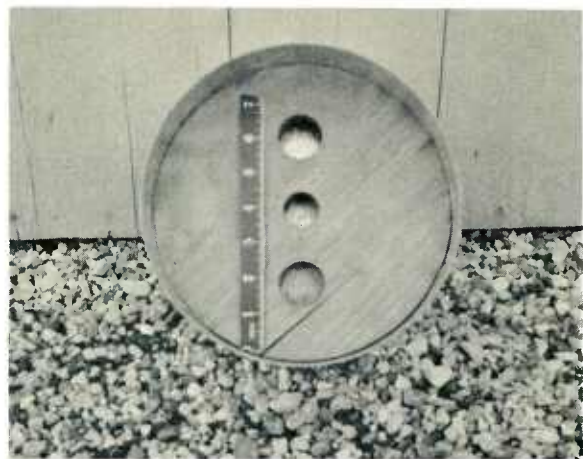
Figure 1

Based on the geometry of the container and the density of the explosive, the weight of each charge was determined in terms of thickness.

a. Galvanized Charge Container
(Left), Plywood Base (Right).

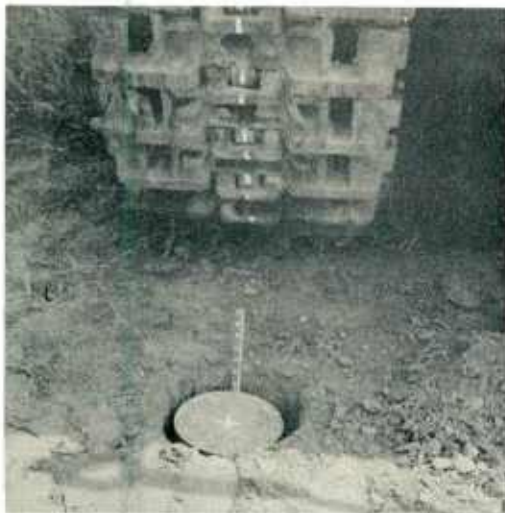
a. Charge Emplacement, Front View.

3.1.1 Emplacement. Each charge was emplaced in front of the tank track with 3 inches of soil cover (see Figures 2 a and 2 b). The lateral position of each charge was obtained by measuring the desired distance inward from an extended line coincidental with the outer edge of the JSIII track. After the charge was emplaced, the distance from its center to the desired longitudinal functioning position on the target tank was measured.

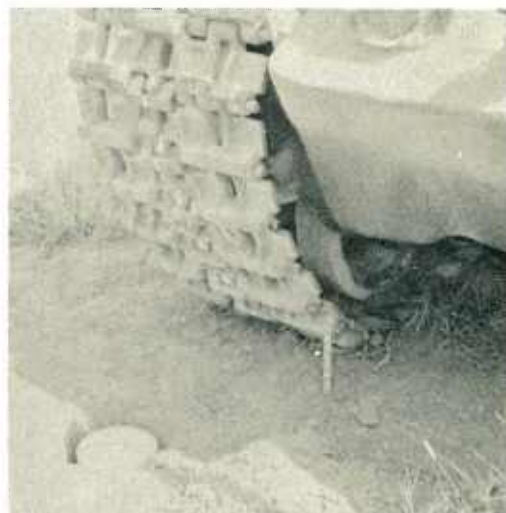
b. Charge Emplacement, Angle View.

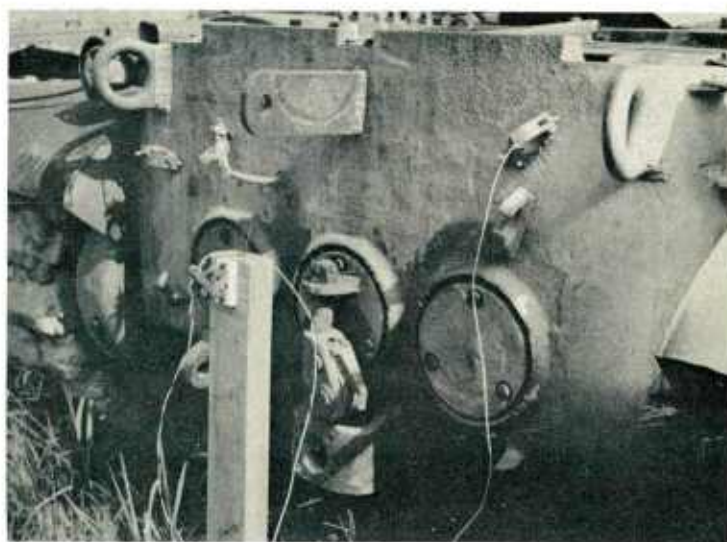
c. Knife Switch, Showing Lanyard Attached to Rear of Target Tank.

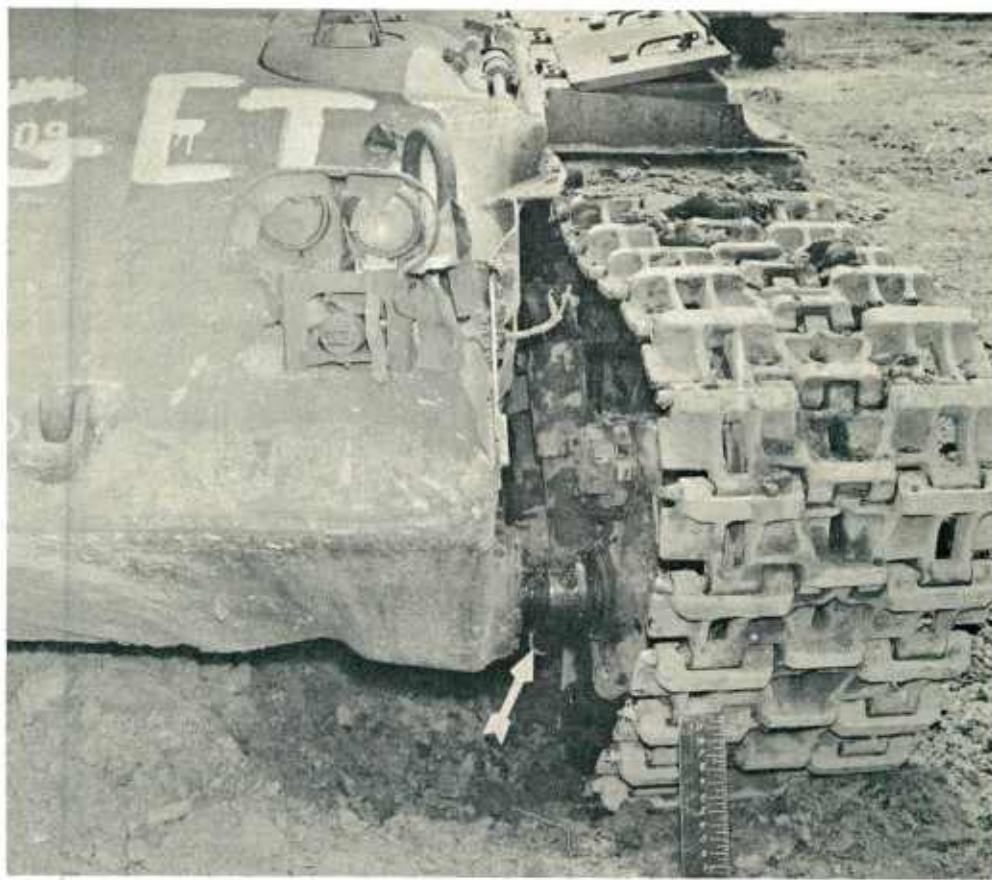
Figure 3 - B30536: Front View of Left Side of U. S. M47 Tank, No. 30164309, After Detonation of Charge No. 2 Under Centerline of No. 1 Road Wheel, Under Lateral Center of the JSIII Track. Charge Consisted of 7.04 Pounds of Comp B Encased in an 8.5-Inch-Diameter, Cylindrical, 24-Gauge, Galvanized Container, Emplaced with 3-Inch Soil Cover.

Figure 3 shows the results of Charge No. 2. Note the separation of the arm from the tank hull. This separation caused the tank to be immobilized. However, the results here were not considered in the evaluation because the damage was believed to be cumulative.

Results (C): Track not severed. One track shoe badly bent and cracked across the center and at the hinge sections. Four other shoes slightly bent and cracked in several of the hinge sections. No. 1 road wheel destroyed. No. 1 bumper spring broken. No. 1 bumper spring housing sheared from tank hull. Front road wheel arm pulled partway out of hull (retainer remained in place). The results are shown in AFG photographs numbered B30534 and B30535 in Appendix C, and B30536 in Figure 3.

Opinion (C): Tank immobilized because of No. 1 wheel and arm damage.

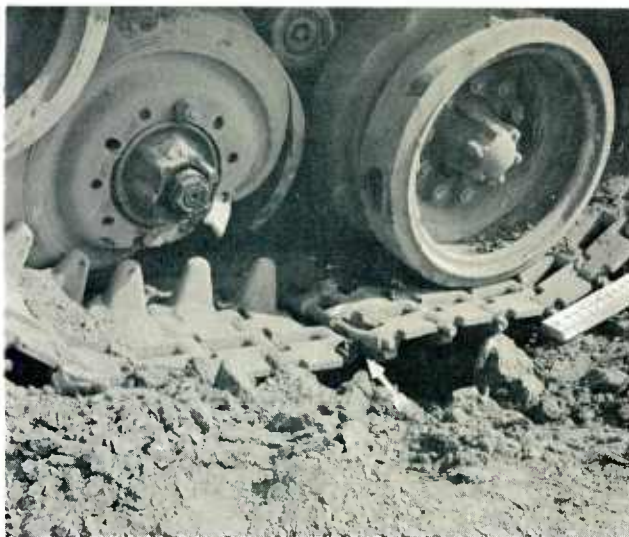
Figure 4 shows the results of Charge No. 3. Note the damage to the road wheel and the track. The track was severed except for a portion of one hinge section. The tank was towed back and forth several times without difficulty or increase in track separation. This will give some indication of the toughness of the JSIII track.

Figure 4 - B31645: Closeup of Left Side of U.S. M47 Tank No. 30164309 After Detonation of Charge No. 3 Under Centerline of No. 1 Road Wheel Under the Lateral Center of the JSIII Track. Charge Consisted of 8.05 Pounds of Comp B Encased in an 8.5-Inch-Diameter, Cylindrical, 24-Gauge, Galvanized Container Emplaced with 3-Inch Soil Cover.

Results (C): Track severed except for a portion of one hinge section on the inboard side of the track. Two track shoes badly bent, broken in half at the center, broken at the hinge sections, and the centerguide broken in both. One other shoe badly bent with breaks at the hinge sections. Six other shoes slightly bent with cracks at the hinge sections. No. 1 road wheel destroyed, outer disk blown off a distance of approximately 150 feet. The results are shown in AFG photographs B31645 in Figure 4, and B31646 in Appendix C.

The tank was towed back and forth a number of times. The damaged No. 1 wheel did not seem to interfere. The damaged portion of the track passed over the sprocket repeatedly without difficulty. After the towing, the damaged portion of the track appeared to be the same as before.

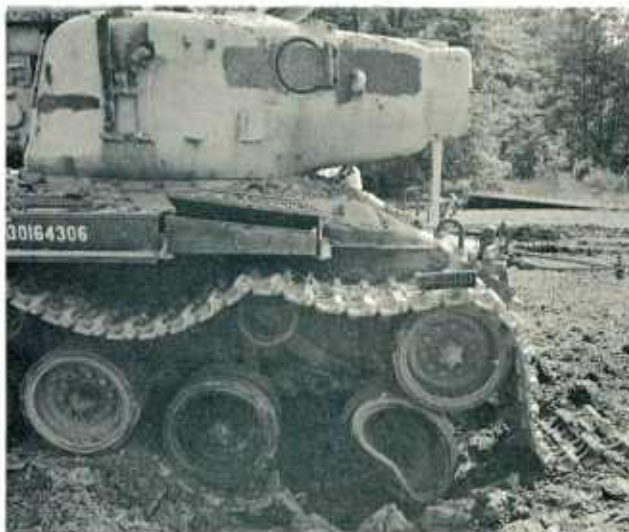
Figure 5 shows the results of Charge No. 4. Note the severed track and damaged road wheel. The damage shown here is similar to that for Charge No. 5.

Figure 5 - B32163: Closeup of Right Side of U.S. M47 Tank, No. 30164306 After Detonation of Charge No. 4 Under Centerline of No. 1 Road Wheel Under Lateral Center of the JSIII Track. Charge Consisted of 8.95 Pounds of Comp B Encased in an 8.5-Inch-Diameter, Cylindrical, 24-Gauge, Galvanized Container. Emplaced with 3-Inch Soil Cover.

Results (C): Track severed. Blew most of one track shoe out. Broke another in half. Three others slightly bent and cracked at the hinge sections. Destroyed No. 1 road wheel. Broke No. 1 bumper spring. Destroyed No. 2 shock absorber. The results are shown in AFG photographs B32163 in Figure 5, and B32164 in Appendix C.

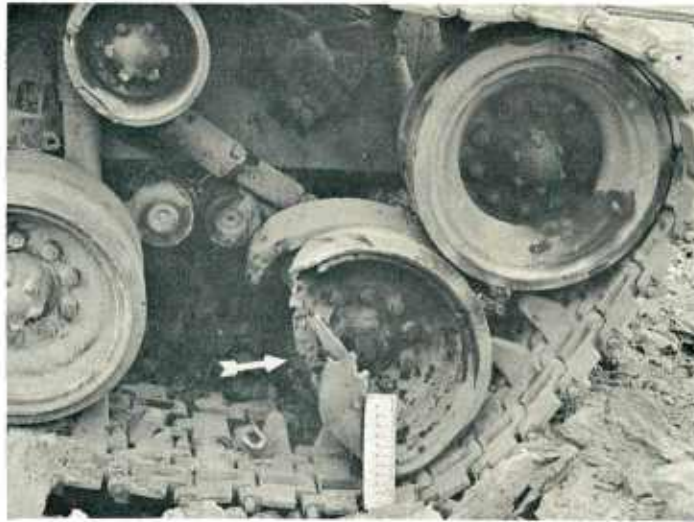
Figure 6 - 58P705: Closeup of Right Side of U.S. M47 Tank, No. 30164306, After Detonation of Charge No. 6 Under Centerline of No. 1 Road Wheel Under the Lateral Center of the JSIII Track. Charge Consisted of 8.96 Pounds of Comp B Encased in an 8.5-Inch-Diameter, Cylindrical, 24-Gauge, Galvanized Container. Emplaced With 3-Inch Soil Cover.

Figures 6 and 7 show some of the results of Charge No. 6. The condition of the front roadwheel in Figure 6 and other suspension damage not shown, is believed to be sufficient to immobilize the tank. The arm separation from the tank, shown in Figure 7, was disregarded because it might have been cumulative from Charge No. 4.

Results (C): Track not severed. Two track shoes badly bent and broken, with the centerguide blown out of one and cracked in the other. Two other track shoes slightly bent and cracked at the hinge sections. No. 1 road wheel destroyed. Front road wheel arm pulled out of the retainer approximately six inches (retainer remained in place). Shackle blown off front arm, shackle bushing destroyed. No. 2 shock absorber destroyed, upper bracket sheared from tank hull. Results are shown in APG photographs numbered 58P705 and 58P707, in Figures 6 and 7, and 58P706 in Appendix C.

Opinion (C): Tank was immobilized because the front road wheel arm pulled out of the hull, and the No. 1 road wheel was severely damaged.

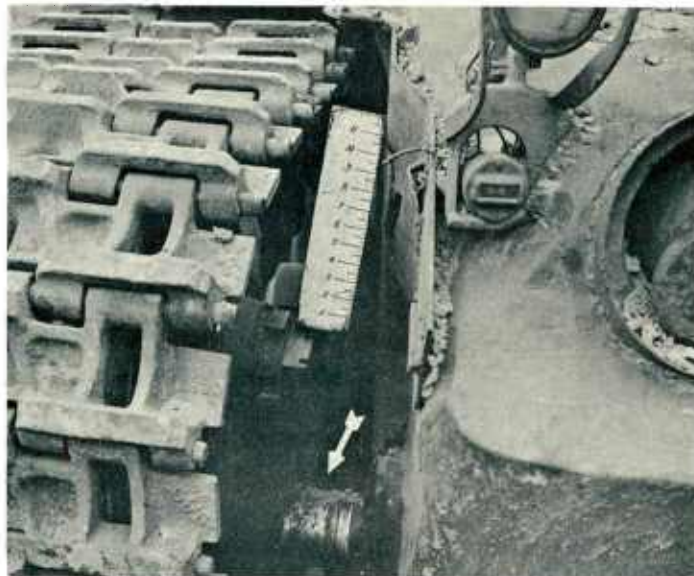
Figure 7 - 58P707: Front View Closeup of Right Side of U.S. M47 Tank, No. 30164306, After Detonation of Charge No. 6 Under Centerline of No. 1 Road Wheel Under the Lateral Center of the JSIII Track. Charge Consisted of 8.96 Pounds of Comp B Encased in an 8.5-Inch-Diameter Cylindrical, 24-Gauge, Galvanized Container. Emplaced with 3-Inch Soil Cover.

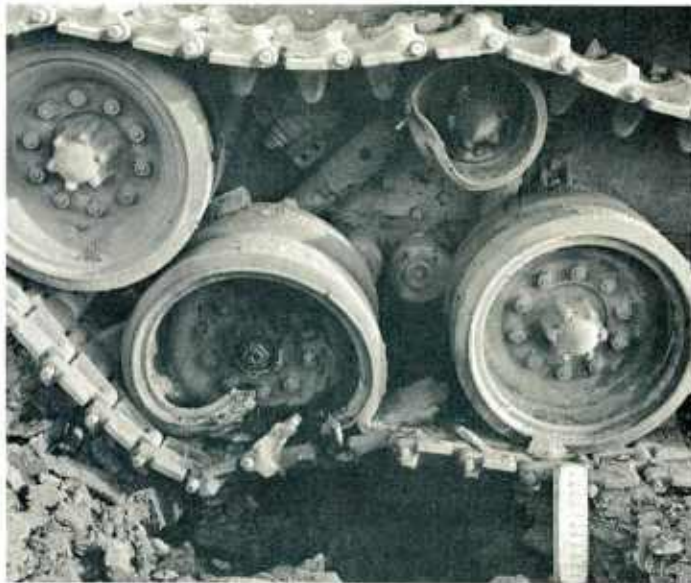
Figure 8 - 58P724: Closeup of Left Side of U.S. M47 Tank, No.30164309, After Detonation of Charge No. 7 Under Centerline of No. 1 Road Wheel With Outer Edge of Charge Tangent to Outer Edge of the JSIII Track. Charge consisted of 9.30 Pounds of Comp B Encased in an 8.5-Inch-Diameter, Cylindrical, 24-Gauge, Galvanized Container. Emplaced with 3-Inch Soil Cover.

Figure 8 shows the result of Charge No. 7. This figure shows the decreased effectiveness of a charge at position T which would have severed the track at position C.

Results (C): Track not severed. Two track shoes badly bent with outboard ends blown off. One other shoe badly bent and cracked at the hinge sections. Two other shoes slightly bent with cracks at the hinge sections. No. 1 road wheel badly bent. Results are shown in AFG photograph No. 58P724 in Figure 8.

After the charge was detonated, the target tank was towed back and forth a distance of approximately 250 feet. The No. 1 road wheel turned very little but it did not lock the track. The damaged track passed over the sprocket with little difficulty.

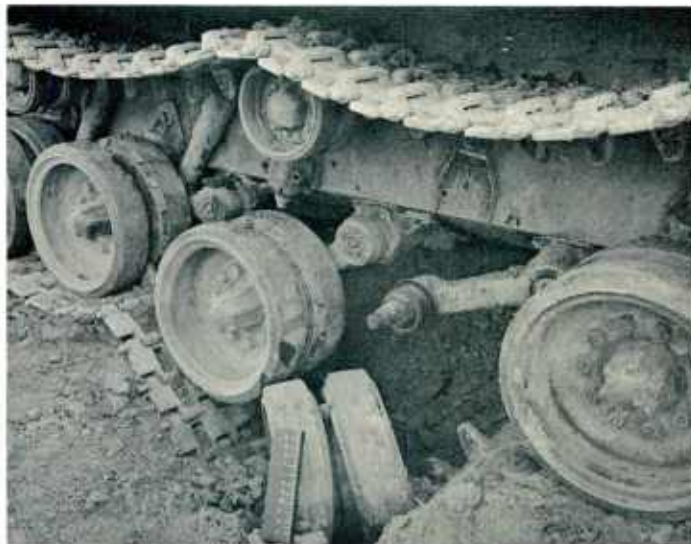
Figure 9 - 59P196: Closeup of Left Side of U.S. M47 Tank, No.30164306, After Detonation of Charge No. 10 Under Centerline of No. 3 Road Wheel Under the Lateral Center of the JSIII Track. Charge Consisted of 5.01 Pounds of Comp B Encased in an 8.5-Inch-Diameter, Cylindrical, 24-Gauge, Galvanized Container. Emplaced with 3-Inch Soil Cover.

Figures 9 and 10 show results of Charges No. 10 and 22 respectively. The results shown in these two figures will tend to give a direct comparison of the minimum weight of Composition B and H6 required to immobilize the tank. The broken road wheel arm in Figure 10 cannot be explained. The arm was new, so the break could not have been the result of repeated shock loads.

Results (C): Track severed. One track shoe blown in half, one other badly bent and broken at the hinge sections, and three others slightly bent and cracked at the hinge sections. No. 3 road wheel destroyed. No. 3 bumper spring assembly sheared from hull, spring and housing separated. No. 4 road wheel slightly bent. Results are shown in AFG photographs No. 59F182 in Appendix C, and 59F196 in Figure 9.

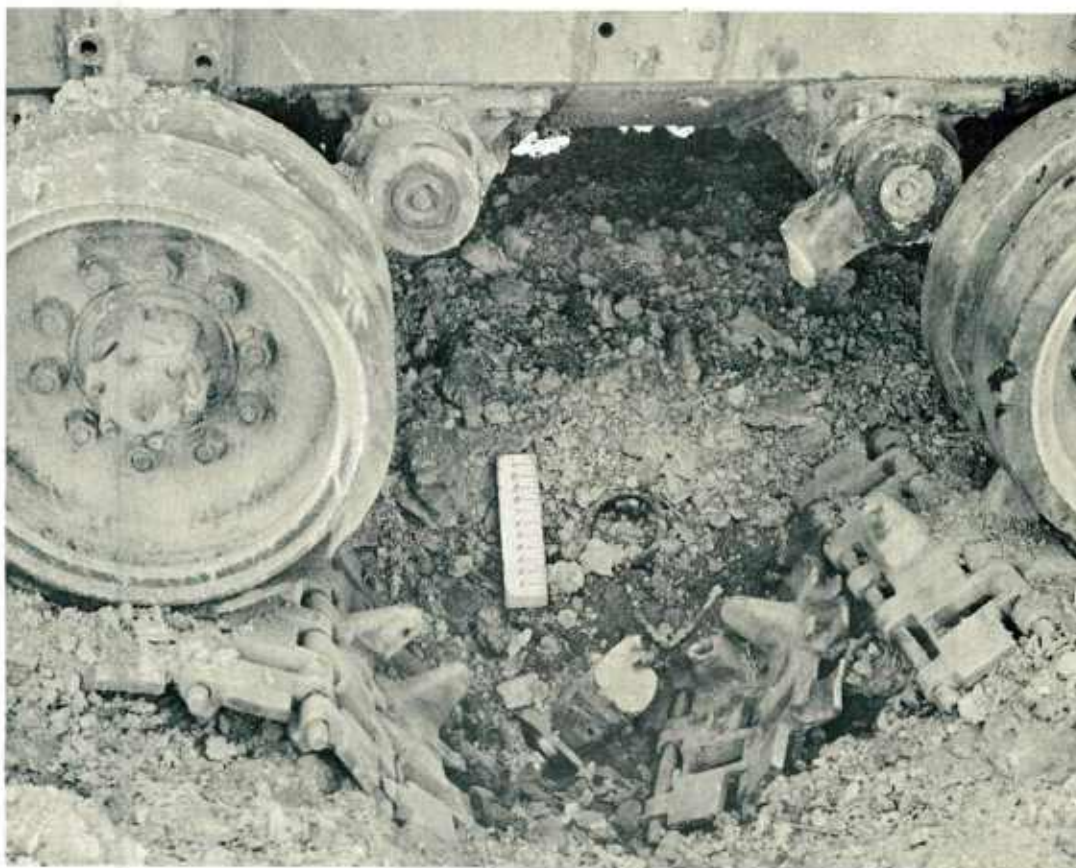
Figure 10 - 59T1854: Closeup of Right Side of U.S. M47 Tank, No. 30164306 After Detonation of Charge No. 22 Under Centerline of No. 3 Road Wheel Under Lateral Center of the JSIII Tank Track. Charge Consisted of 2.98 Pounds of H6 Encased in an 8.5-Inch-Diameter, Cylindrical, 24-Gauge, Galvanized Container. Emplaced with 3-Inch Soil Cover.

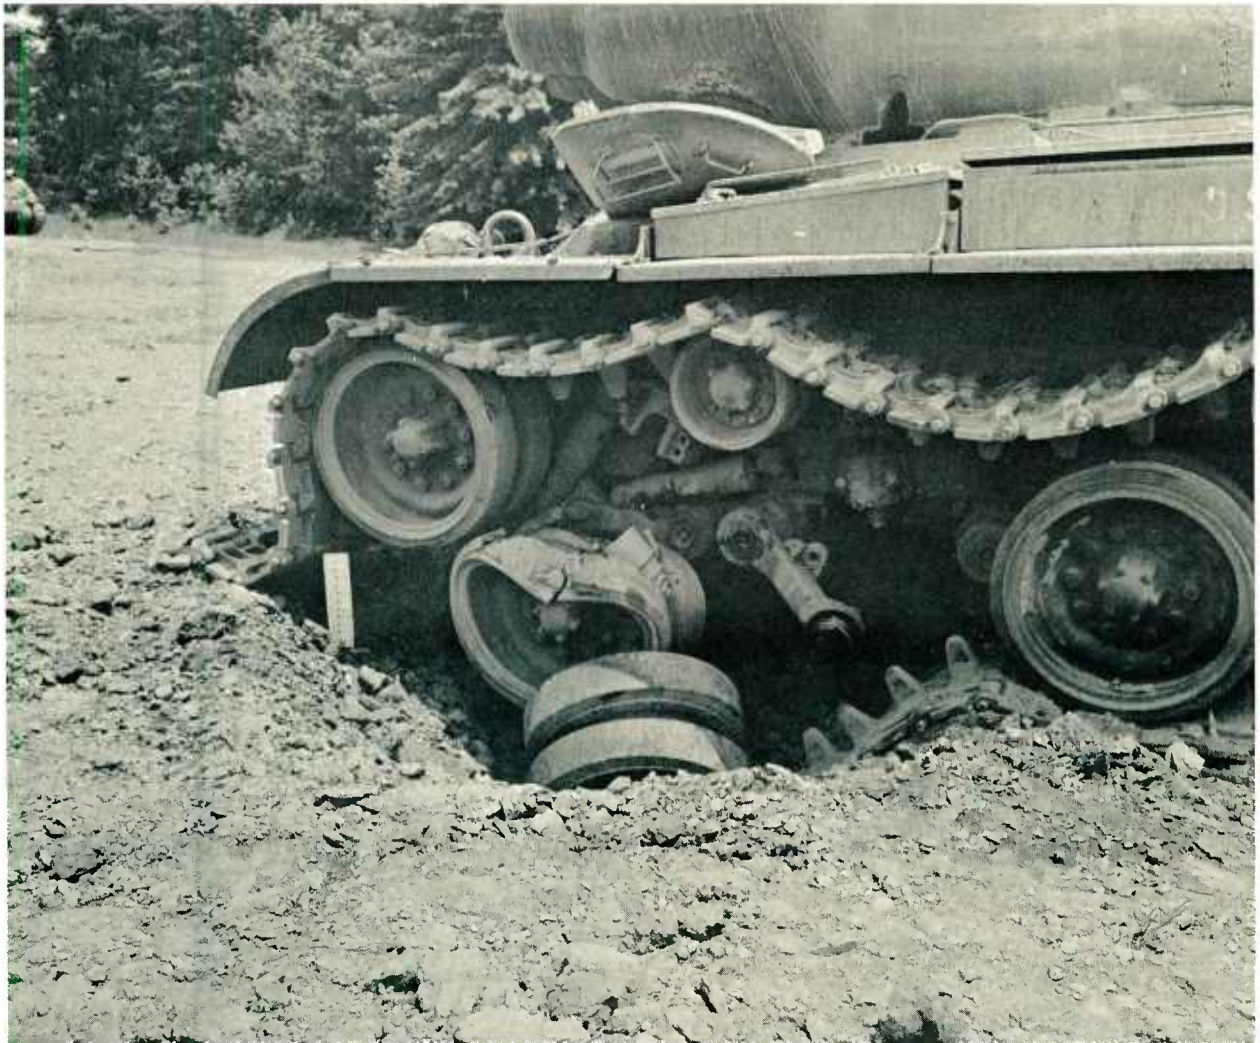
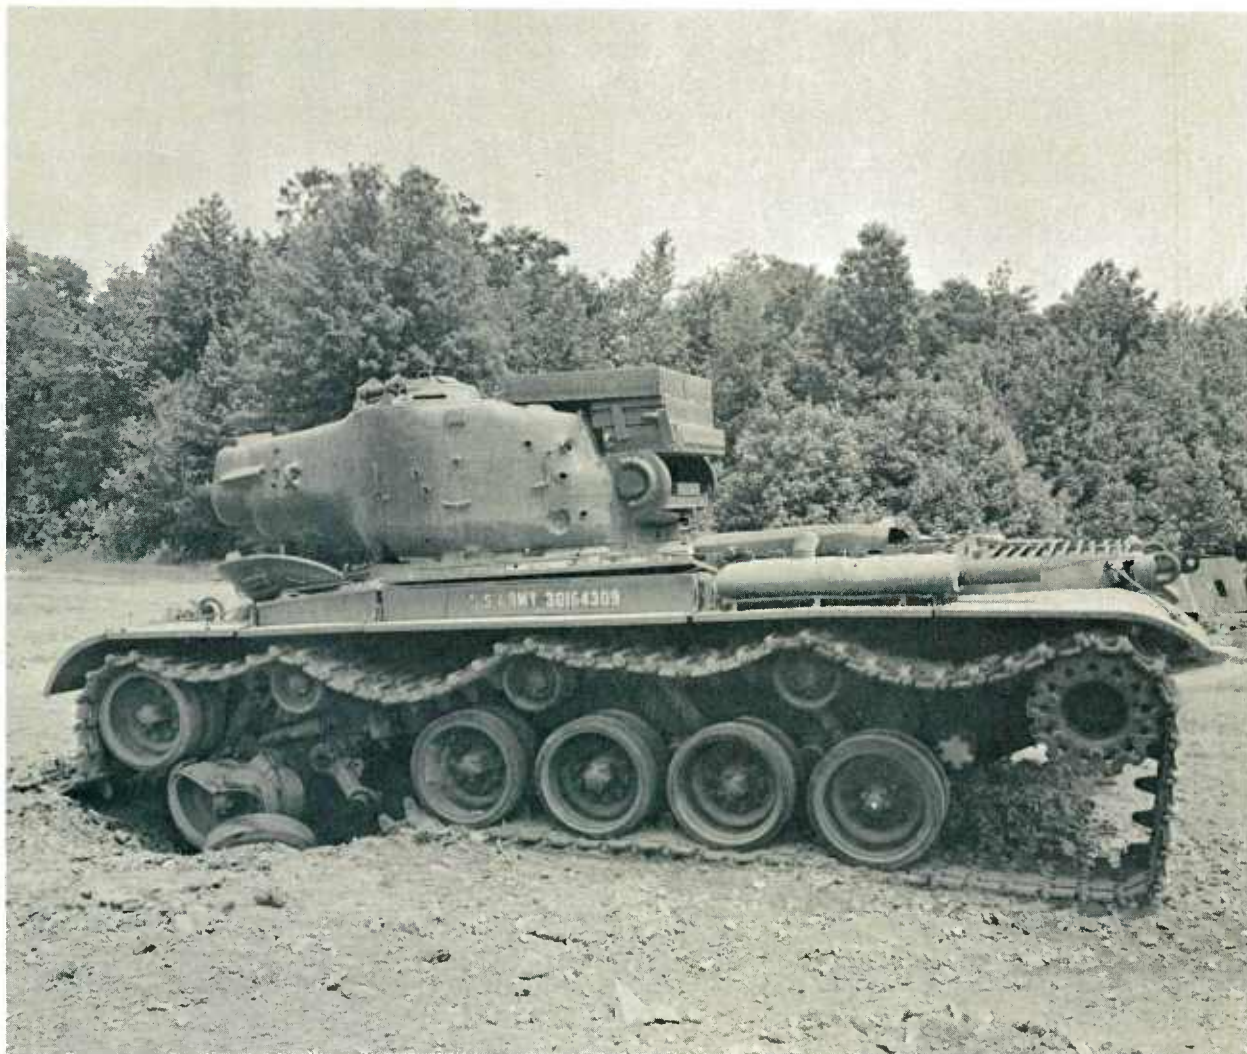
B30399: Close-up of Left Side of U. S., M47 Tank, No. 30164309, After Detonation of Charge No. 1 Under Centerline of No. 1 Road Wheel Under the Lateral Center of the JSIII Track. Charge Consisted of 9.54 Pounds of Comp B Encased in an 8.5-Inch Diameter Cylindrical 24-Gauge Galvanized Container. Emplaced with 3-inch Soil Cover.

B30400: General View of Left Side of U. S., M47 Tank, No. 30164309, After Detonation of Charge No. 1 Under Centerline of No. 1 Road Wheel Under the Lateral Center of the JSIII Track. Charge Consisted of 9.54 Pounds of Comp B Encased in an 8.5-Inch Diameter Cylindrical 24-Gauge Galvanized Container. Emplaced with 3-Inch Soil Cover.

Results (C): Track severed over charge. One shoe broken in half. Two other shoes badly bent and broken at hinge sections. Six other shoes slightly bent with cracks at hinge sections. No. 1 road wheel destroyed but not blown off. No. 2 road wheel blown off, hub and bearings were destroyed. No. 1 bumper spring broken, separated from spring housing which was sheared from the tank hull. No. 2 bumper spring broken. No. 1 shock absorber bracket sheared from tank hull. No. 2 shock absorber destroyed, upper bracket sheared from tank hull. Bearings in idler wheel were crushed. The results are shown in APG photographs numbered B30399 and B30400 in Appendix C.

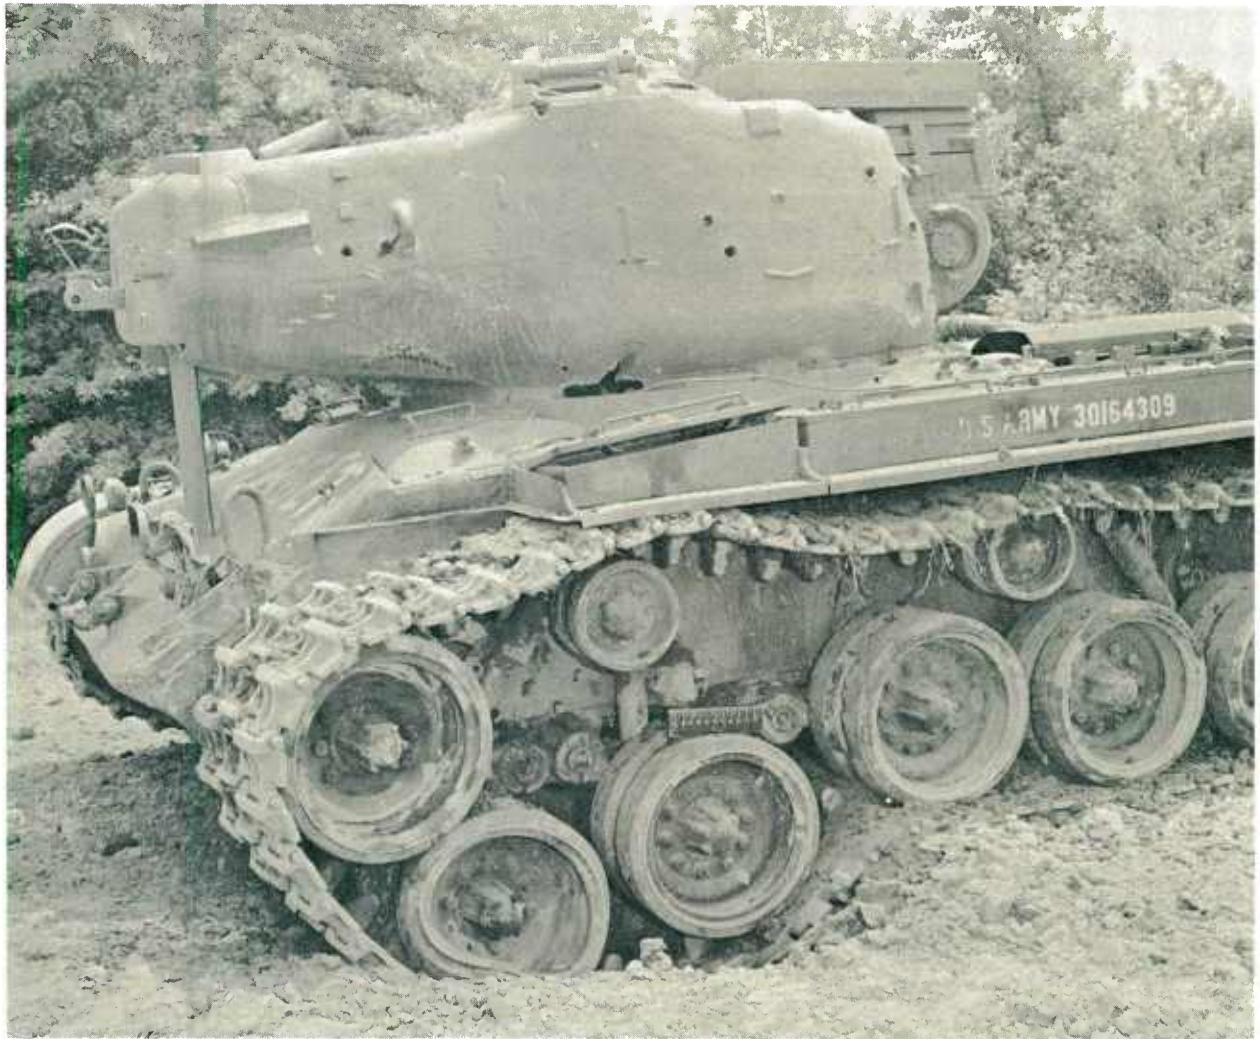
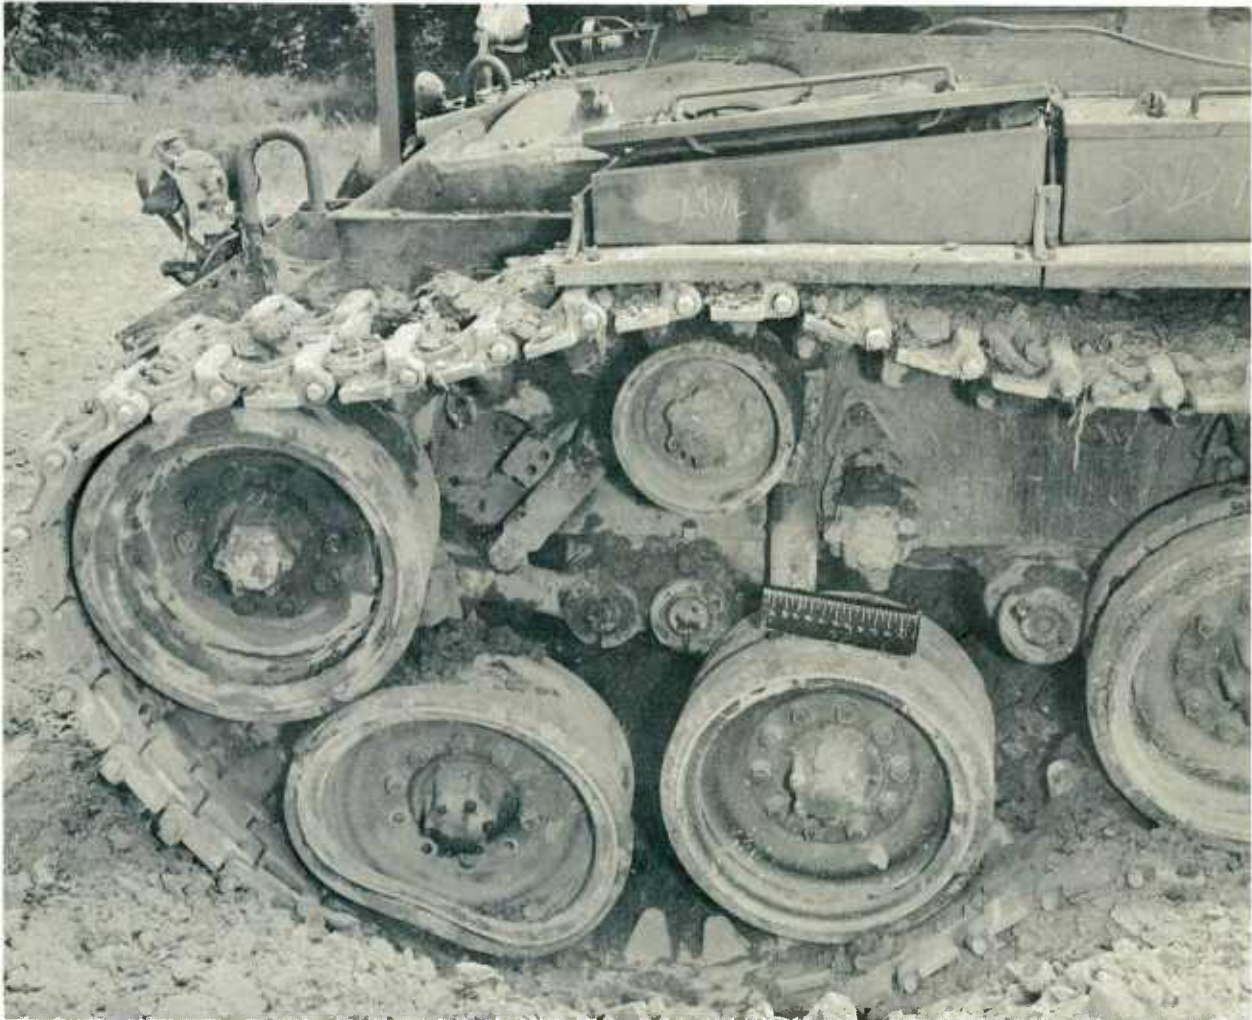
B30534: General View of Left Side of U. S. M47 Tank, No. 30164309, After Detonation of Charge No. 2 Under Centerline of No. 1 Road Wheel, Under Lateral Center of the JSIII Track. Charge Consisted of 7.04 Pounds of Comp E Encased in an 8.5-Inch Diameter Cylindrical 24-Gauge Galvanized Container Emplaced with 3-Inch Soil Cover.

B30535: Close-up of Left Side of U. S. M47 Tank, No. 30164309, After Detonation of Charge No. 2 Under Centerline of No. 1 Road Wheel, Under Lateral Center of the JSIII Track. Charge Consisted of 7.04 Pounds of Comp B Encased in an 8.5-Inch Diameter Cylindrical 24-Gauge Galvanized Container, Emplaced with 3-Inch Soil Cover.

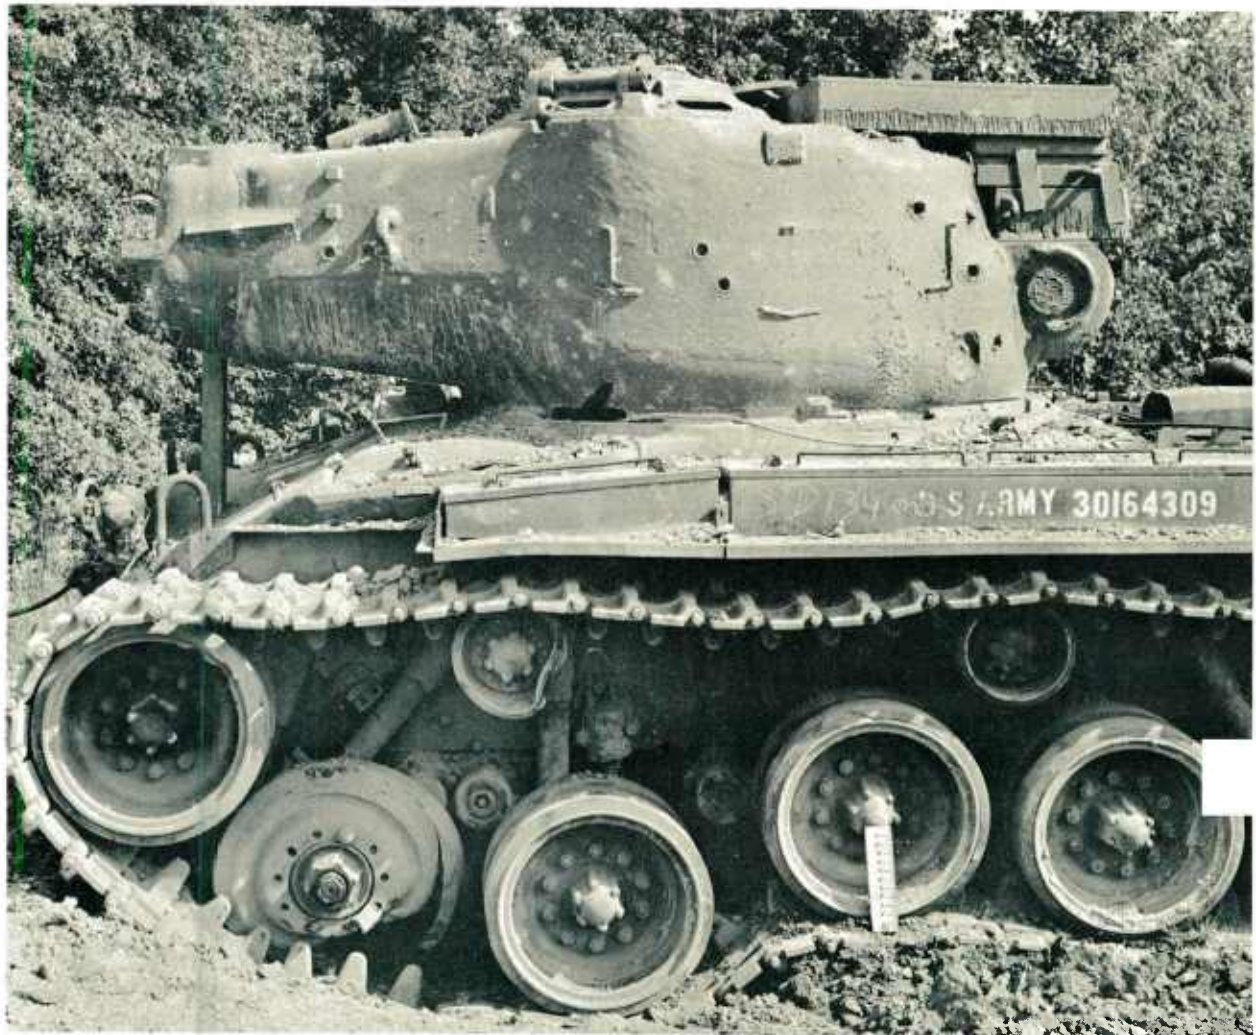
B31646: General View of Left Side of U. S. M47 Tank, No. 30164309 After Detonation of Charge No. 3 Under Centerline of No. 1 Road Wheel Under the Lateral Center of the JSIII Track. Charge Consisted of 8.05 Pounds of Comp B Encased in an 8.5-Inch Diameter Cylindrical 24-Gauge Galvanized Container Emplaced with 3-Inch Soil Cover.

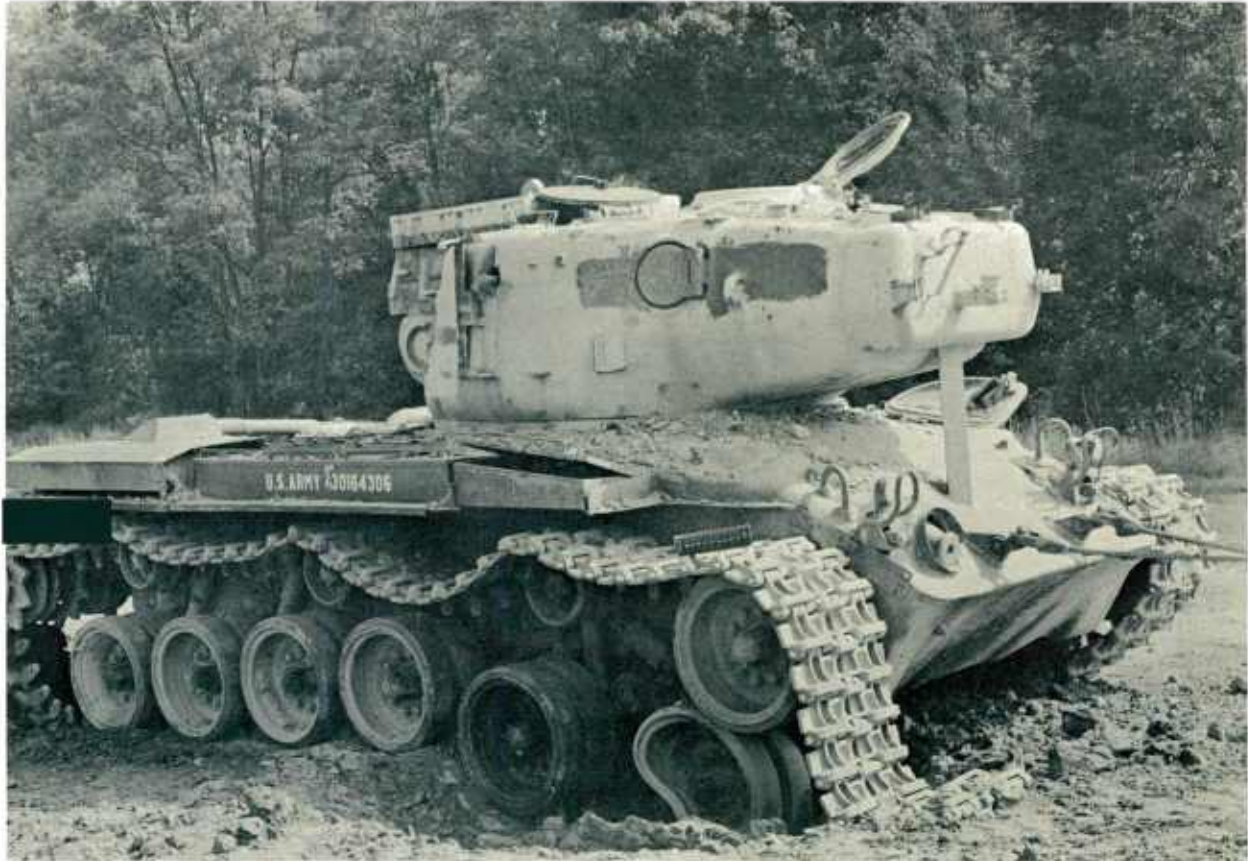
B32164: General View of U. S. M47 Tank, No. 30164306 After Detonation of Charge No. 4 Under Centerline of No. 1 Road Wheel Under Lateral Center of JSIII Track. Charge Consisted of 8.95 pounds of Comp B Encased in an 8.5-Inch Diameter Cylindrical 24-Gauge Galvanized Container. Emplaced with 3-Inch Soil Cover.

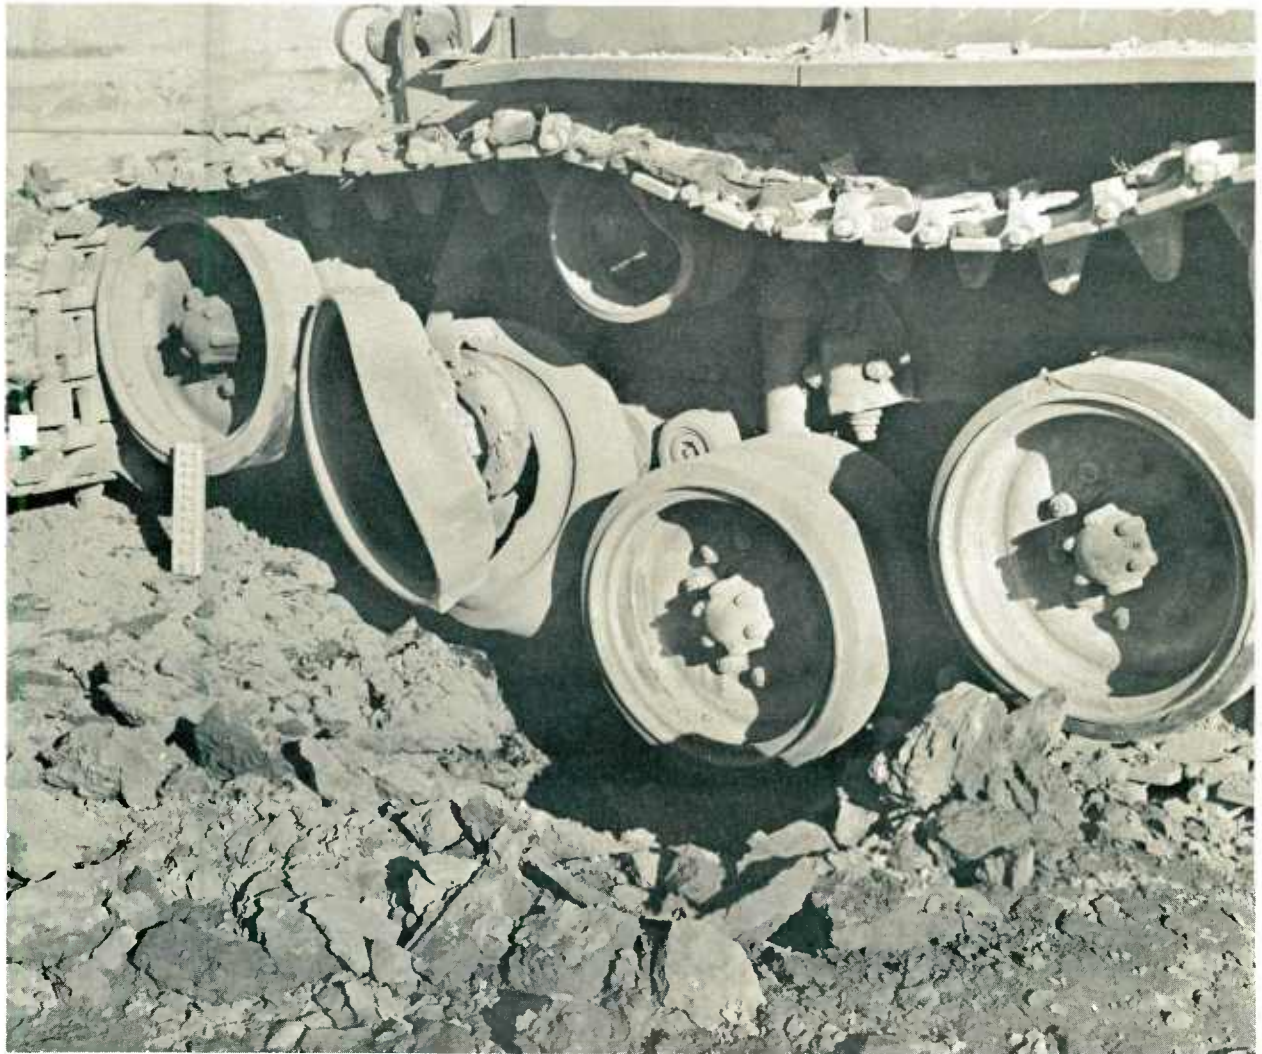
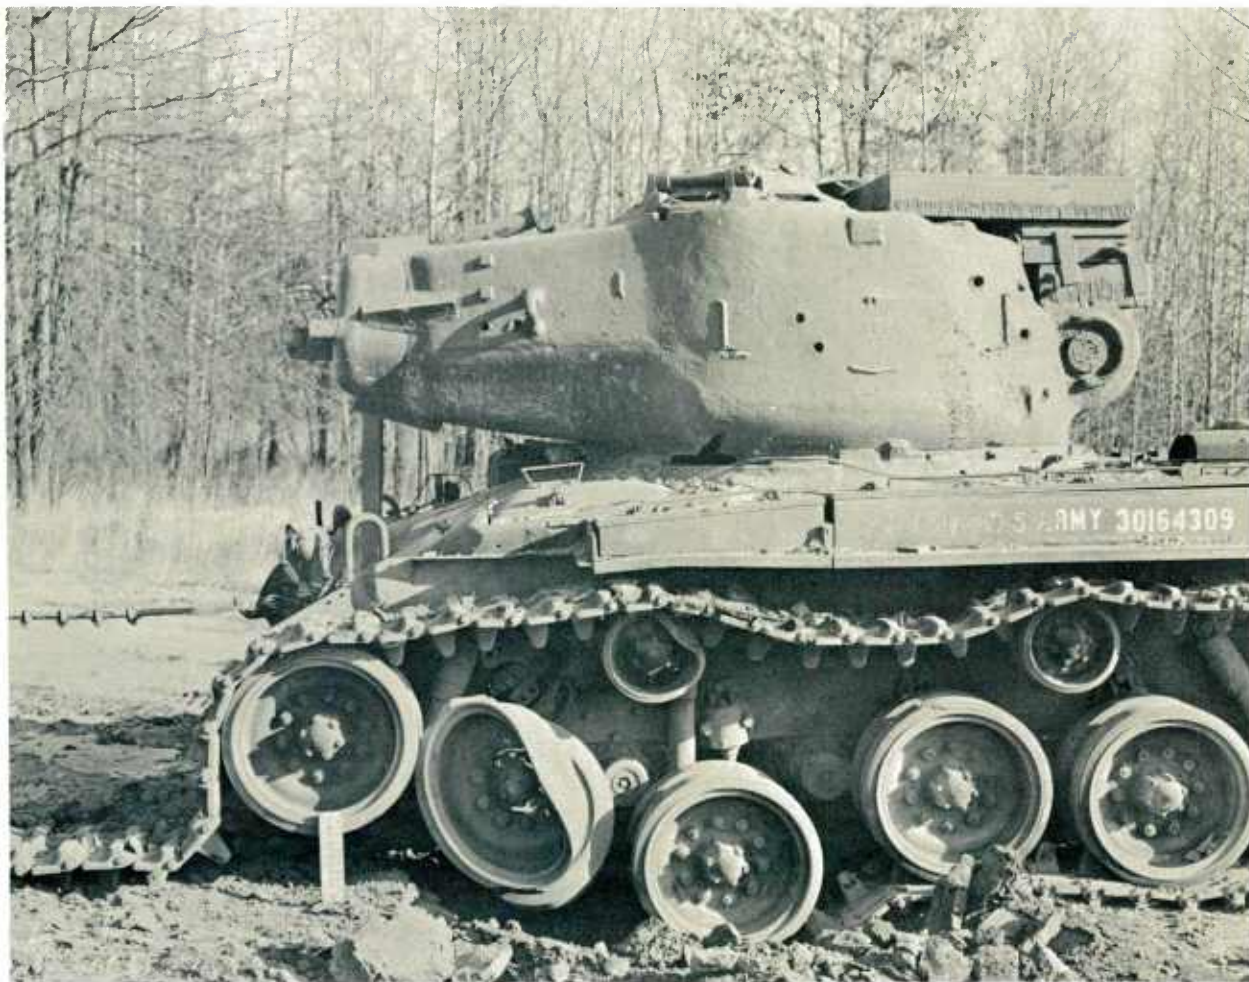
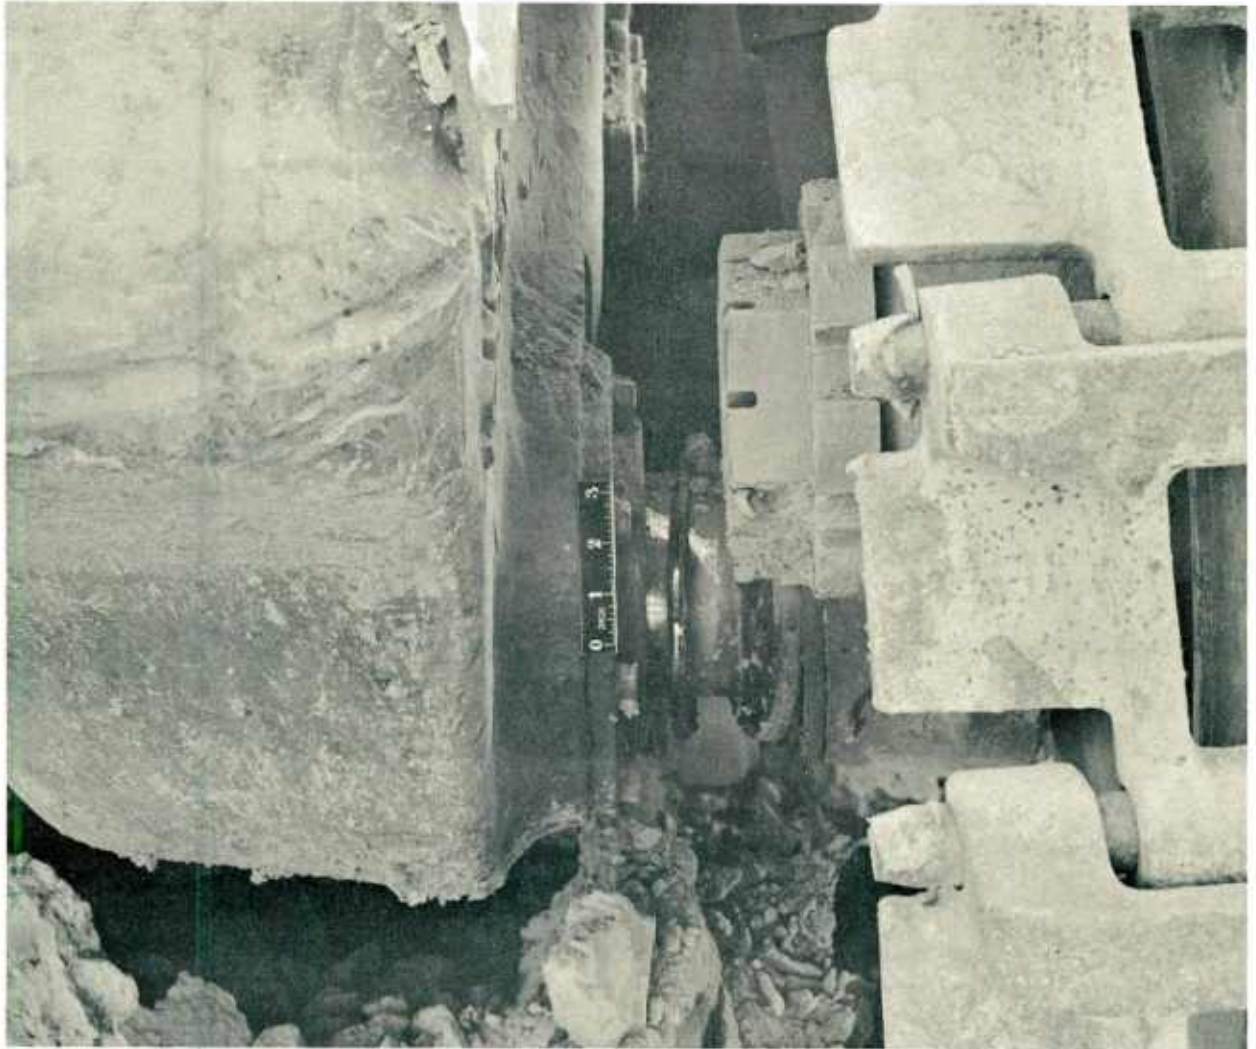
58T596: Close-up of Left Side of U. S. M47 Tank, No. 30164309, After Detonation of Charge No. 5 Under Centerline of No. 1 Road Wheel Under the Lateral Center of the JSIII Track. Charge Consisted of 9.03 Pounds of Comp B Encased in an 8.5-Inch Diameter Cylindrical 24-Gauge Galvanized Container. Emplaced with 3-Inch Soil Cover.

58T597: General View of Left Side of U. S. M47 Tank, No. 30164309, After Detonation of Charge No. 5 Under Centerline of No. 1 Road Wheel Under the Lateral Center of the JSIII Track. Charge Consisted of 9.03 Pounds of Comp B Encased in an 8.5-Inch Diameter Cylindrical 24-Gauge Galvanized Container. Emplaced with 3-Inch Soil Cover.

58T598: Close-up Front View of Left Side of U.S. M47 Tank, No.30164309, After Detonation of Charge No. 5 Under Centerline of No. 1 Road Wheel Under the Lateral Center of the JSIII Track. Charge Consisted of 9.03 Pounds of Comp B Encased in an 8.5-Inch Diameter Cylindrical 24-Gauge Galvanized Container. Emplaced with 3-Inch Soil Cover.

Results (C): Track severed. Two track shoes badly bent, blown in half with part of both centerguides blown out. Four other track shoes slightly bent with cracks in the hinge sections. No. 1 road wheel destroyed. No. 1 and No. 2 shock absorbers destroyed. No. 1 bumper spring housing almost sheared from tank hull. Front road wheel arm badly damaged, shackle blown loose from arm. Front road wheel arm pulled from tank hull. The results are shown in APG photographs numbered 58T596, 58T597, and 58T598, in Appendix C.

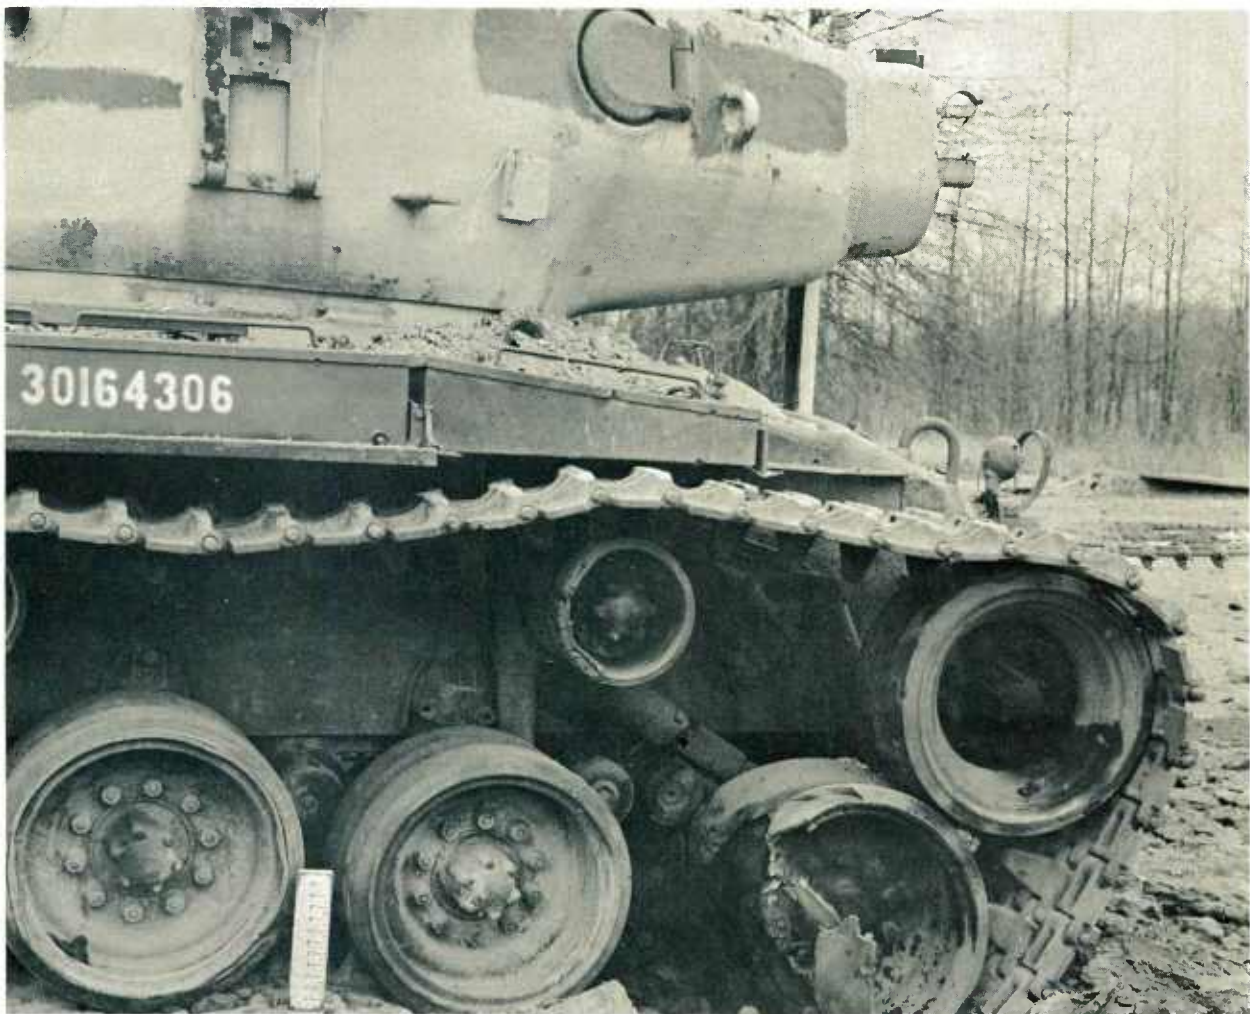
58P706: General View of Right Side of U.S. M47 Tank, No. 30164306, After Detonation of Charge No. 6 Under Centerline of No. 1 Road Wheel Under the Lateral Center of the JSIII Track. Charge Consisted of 8.96 Pounds of Comp B Encased in an 8.5-Inch Diameter Cylindrical 24-Gauge Galvanized Container. Emplaced with 3-Inch Soil Cover.
